Documentation and Disaster Planning Supports Cultural Heritage Items' Authenticity and Integrity in Disaster Situations

Heidi Wirilander, MA in conservation and in museology, PhD student of museology, University of Jyväskylä

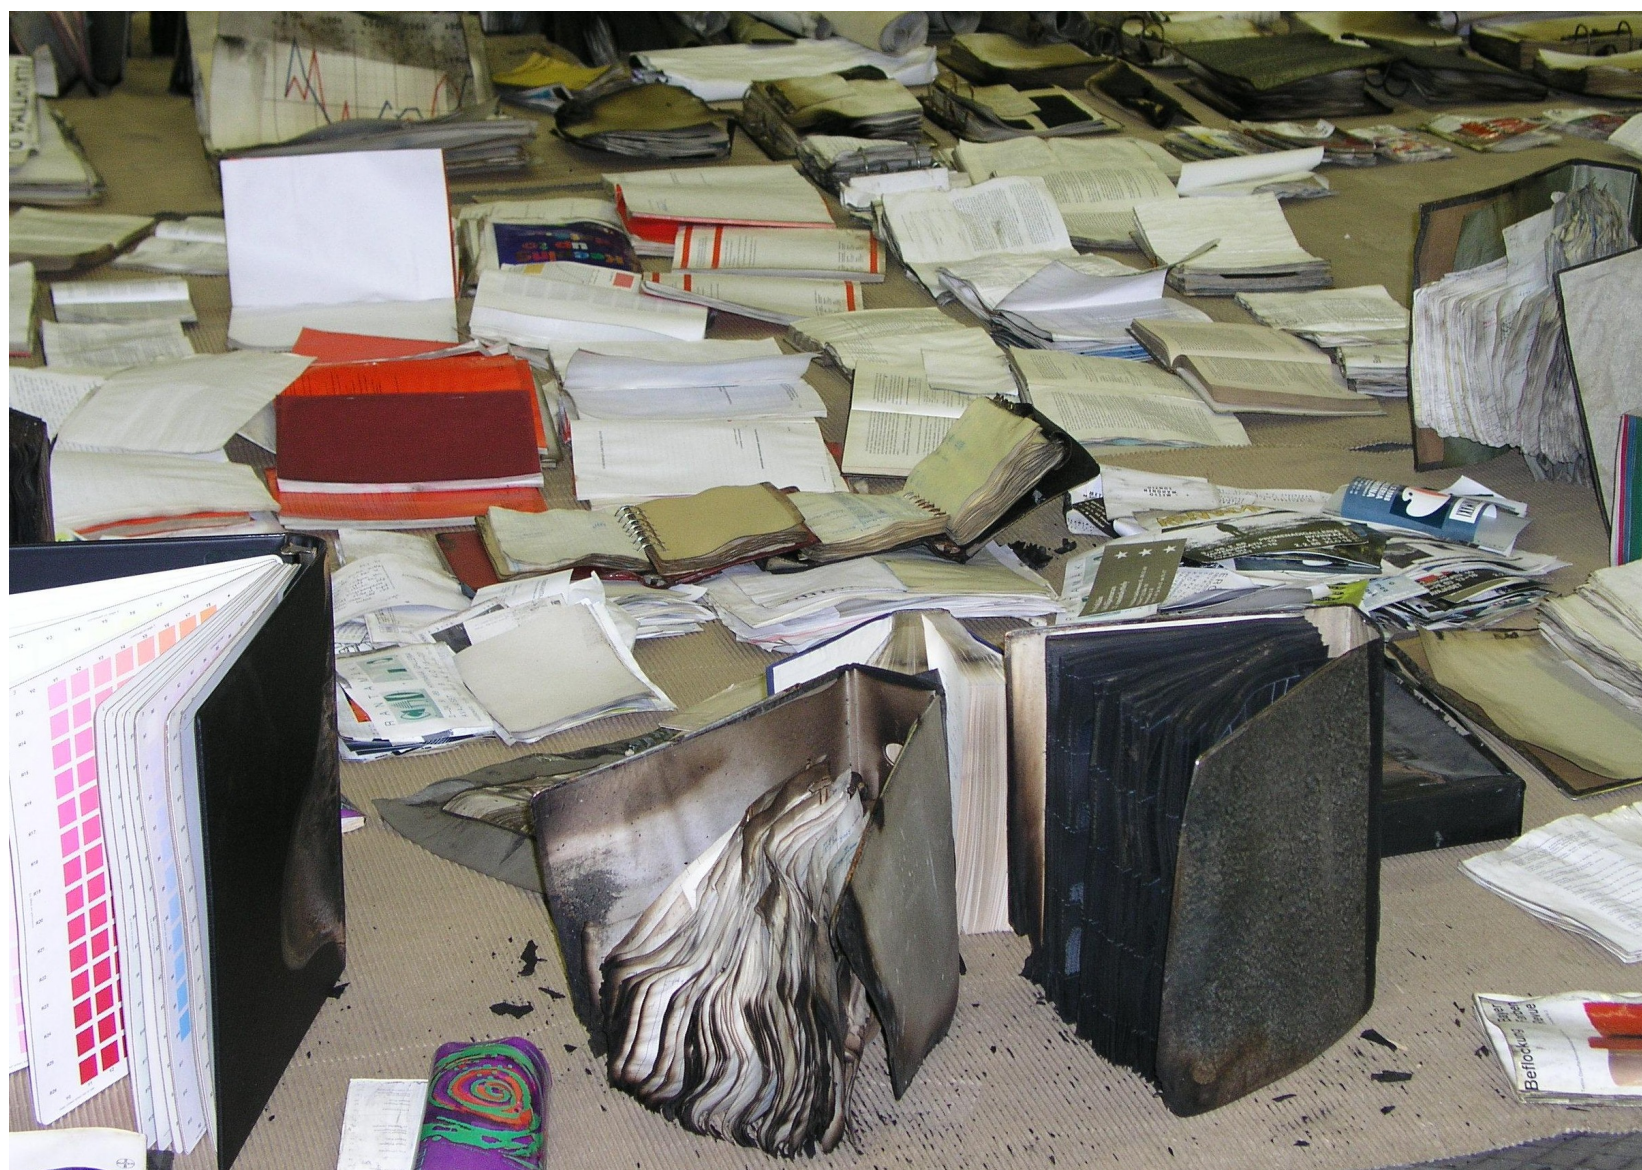
The textile sample notebooks were placed open in the vertical position on large tables, book shelves, and on the floor was protected with dust jacket. Drying papers that also held the book pages open were placed between book pages (Fig.2). Large fans were used in the production hall in the air-drying process. Hand dryers were used for more localized drying of individual sample notebooks. Unfortunately, the textile samples were attached to the book pages with water-soluble glue and, in some cases, the large fans' powerful airflow blew some of the textile samples out of the notebook pages. This resulted in some textile samples losing their link to their context information because the information existed only in the original notebook pages and covers that were badly damaged and cut out of the books.

Fig. 2. Air drying of the damaged archival collections after the fire. (Picture: the Hyvinkää City museum©).

Elements that could have increased the efficiency of the air-drying, such as wind tunnels or blotting papers under the sample books, were not utilized in this case. The paper type that was used under the items did not have similar suction quality as the blotting paper had. Also, the dehumidifying process was not particularly effective in the production hall where the drying was performed.

Ineffective aftercare methods were employed due to the lack of planning and resources. This caused more permanent and serious damage to the collection and expanded the need for aftercare and remedial conservation in order to save the collection. The air-drying method was not effective enough to dry entirely wet large archival collection. Because the aftercare was done in crisis without any previous planning or experience with limited material and economic resources, the secondary damage could not be avoided.
